Manhole Inspection Summary

Manhole # S27I__033MH

Location Address: **39 S Poppleton St**

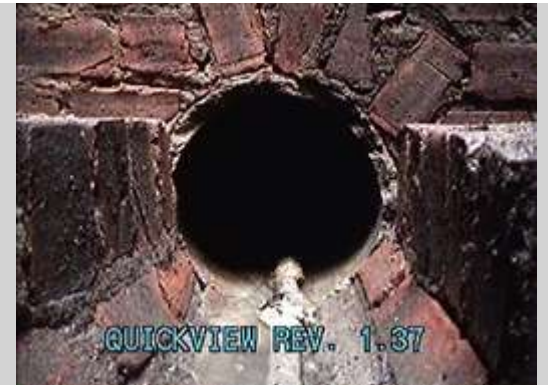
12 O'Clock Outflow

Pipe Height: **8.4** (in.) Rod and Bar (Angled)
Pipe Material: **Clay** ☐ Pipe Lined
Invert Depth: **9.80** (ft.) Flow Characteristics: **Slow**
Deposits: ☒ None ☐ Mud ☐ Sludge ☐ Debris ☐ Grease
Silt Depth: **0** (in.) Deposits Extent:
Infiltration: **None** Pipe Seal Cond: **Sound**

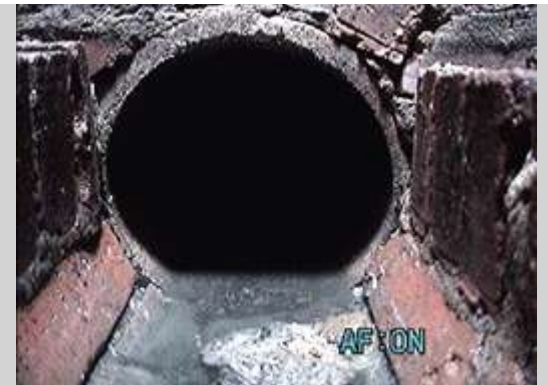
6 O'Clock Inflow

Pipe Height: **8.4** (in.) Rod and Bar (Angled)
Pipe Material: **Clay** ☐ Pipe Lined
Invert Depth: **9.85** (ft.) Flow Characteristics: **Slow**
Deposits: ☒ None ☐ Mud ☐ Sludge ☐ Debris ☐ Grease
Silt Depth: **0** (in.) Deposits Extent:
Infiltration: **None** Pipe Seal Cond: **Sound**

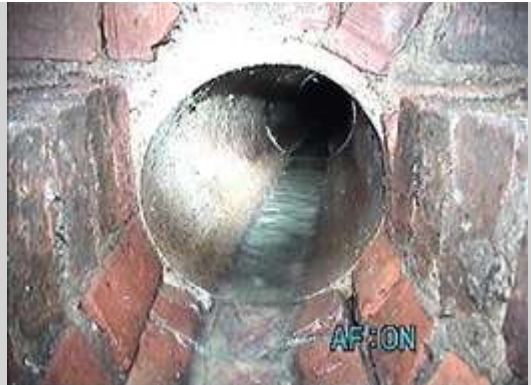
9 O'Clock Inflow

Pipe Height: **8.4** (in.) Rod and Bar (Angled)

Pipe Material: **Clay** ☐ Pipe Lined

Infiltration: **None** Pipe Seal Cond: **Sound**
